SAWMILL RIVER
WATERSHED ASSESSMENT
Franklin County, Massachusetts

Franklin County Soil and Water Conservation District

**United States Department of Agriculture
Natural Resources Conservation Service
Amherst, Massachusetts**

March 2002

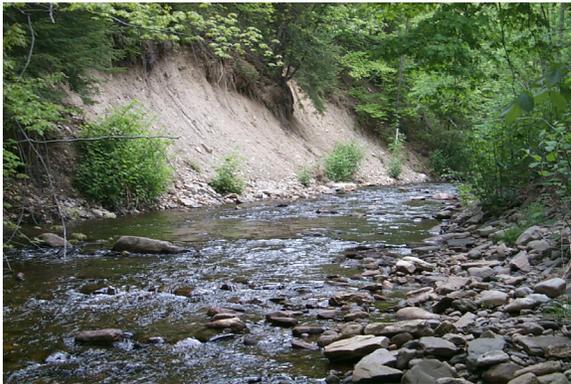
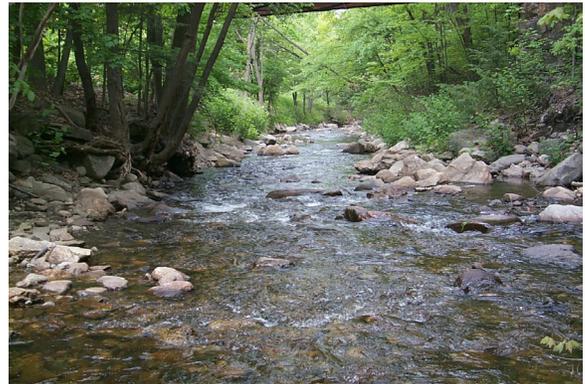
Site 1 looking upstream

General – This site is about 185 feet long and characterized by a steep, eroding right bank, about 20 feet high. There is active bank erosion with some overhanging vegetation and seeps. The bank material is generally gravel. There is a mill building on the left bank. The banks appear stable and well vegetated both upstream and downstream from the site. The channel is somewhat incised and the slope is fairly steep. The riverbed appears stable. The dominant bed materials are cobbles and boulders. Based on visual assessment only, the river is likely a B3/F3 Rosgen classification.

The steep, right bank is eroding due to a lack of vegetative cover and an unstable toe (bottom) of slope. Erosion is categorized as high. It will likely continue as high flows erode the toe and the upper slope and trees fall into the river. The conditions may be a result of the buildings on the left bank confining the higher flows and preventing the river from reaching its floodplain.

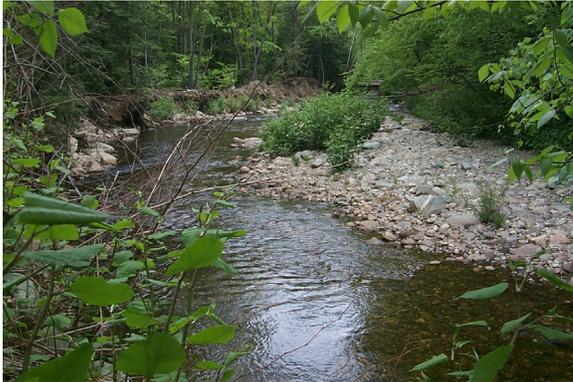
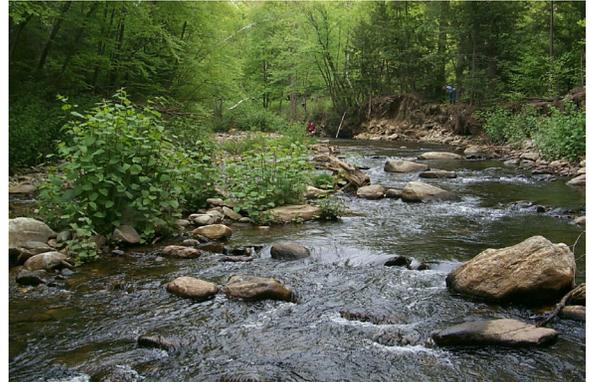
Site 2 looking downstream

General – This site is about 240 feet long and characterized by a nearly vertical eroding left bank, about 8 feet high. There is active bank erosion with overhanging vegetation. The bank material is generally gravel. The erosion is occurring on an outside meander bend. There is a significant point bar on the left bank. The banks appear stable and well vegetated both upstream and downstream from the site. The channel is somewhat incised and the slope is fairly steep. The dominant bed materials are cobbles and boulders. Based on visual assessment only, the river is likely a B3/F3 Rosgen classification.

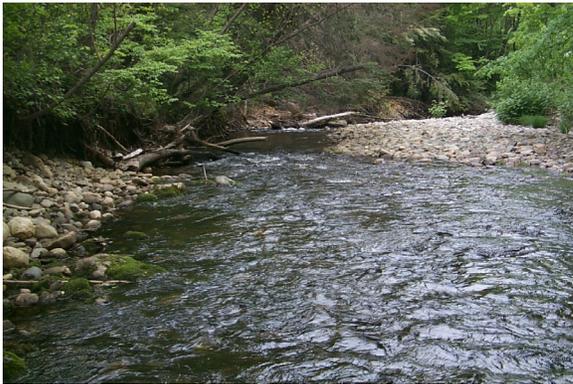
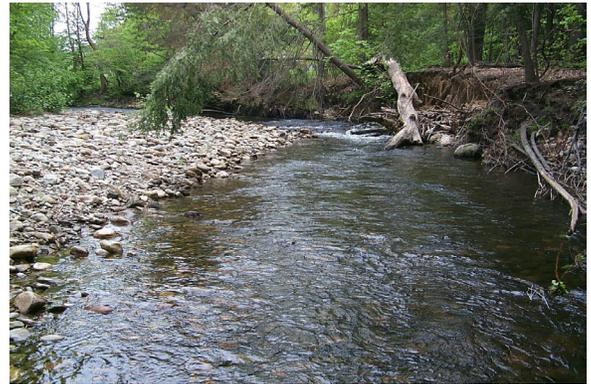
Site 3 looking downstream

General – This site is about 270 feet long and characterized by a nearly vertical eroding left bank, about 8 feet high. There is active bank erosion with some overhanging vegetation. The bank material is generally gravel. The erosion is occurring on an outside meander bend. There is a significant point bar on the left bank. The banks appear stable and well vegetated both upstream and downstream from the site. The channel is somewhat incised and the slope is fairly steep. The riverbed appears stable. The dominant bed materials are cobbles and boulders. Based on visual assessment only, the river is likely a C3 Rosgen classification.

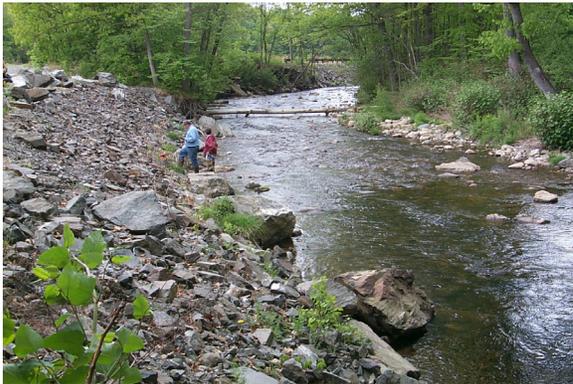
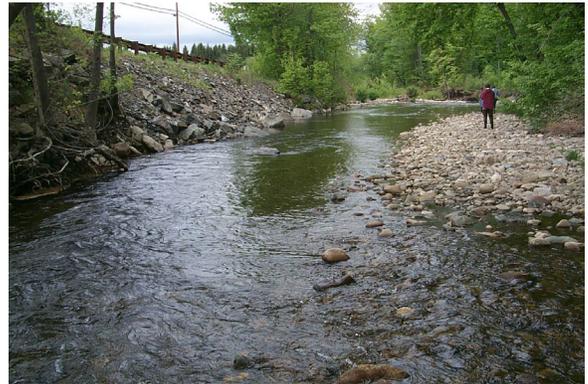
Site 4 looking downstream
Upper Section

Site 4 looking downstream
Lower Section

General – This site is about 160 feet long. It is characterized by two sections of riprap on the left abutment that protects the road. The left bank is about 10 feet high. There is a small area of eroded bank just upstream from the lower riprap section. The channel is low gradient with cobbles and boulders. There is a point bar on the right bank. There is a low berm on the right bank, which is probably a result of past dredging of the river. Both river banks appear stable. Based on visual observation only, the likely Rosgen classification is C3/F3.

12. The eroded area at the upstream end of the riprap at Site 4 should be evaluated by highway personnel and repaired as necessary. Future storms could undermine the riprap and impact the road embankment. (S)

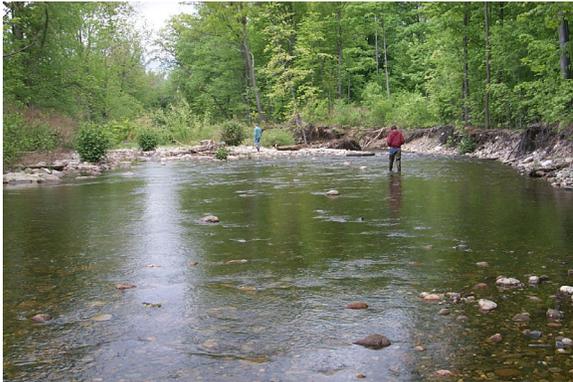
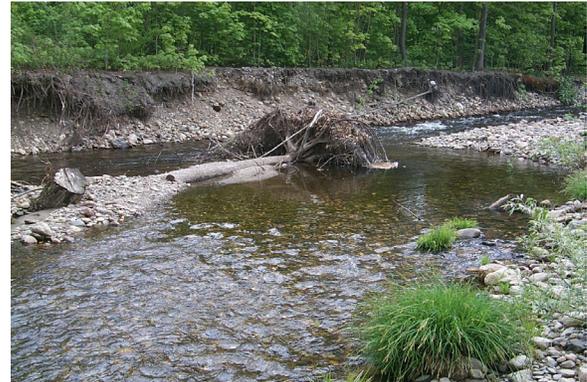
Site 5 looking downstream

General – This site is about 360 feet long and characterized by a near vertical eroding right bank about 6 feet high. There is active bank erosion with some overhanging vegetation. The bank material is generally gravel. Erosion is occurring on the outside meander bend. There is a large gravel point bar that is beginning to revegetate. The riverbed appears to be aggrading. The dominant bed materials are gravel and cobbles. Based on a visual assessment only, the river is likely a C4 Rosgen classification.

9. Site 5, adjacent to Sunderland Road, is aggrading and experiencing severe erosion. This area is likely contributing sediment to downstream areas. Stream restoration and sediment/debris removal is recommended. **(L)**

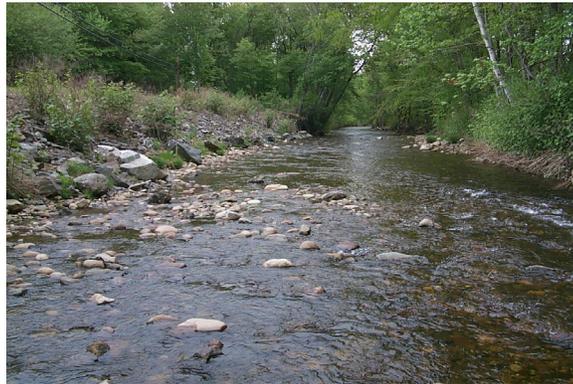
Site 6 looking downstream

General – The site is about 70 feet long. The banks are about 10 feet high. There is riprap on the left bank that protects the road embankment. The banks and riverbed appear stable.

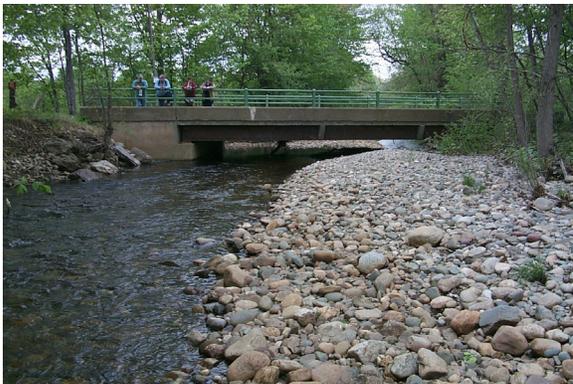
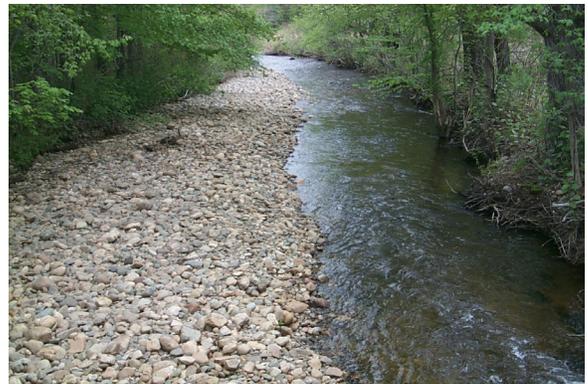
Site 7 looking downstream
at South Street

Site 7 looking downstream
from South Street

General – The entrance and exit channels and the bridge opening are clogged with sediment. The channel makes a right turn under the bridge. The flow capacity is seriously reduced. The channel slope is fairly flat. The sediment is cobbles and coarse gravel. The riverbanks near the bridge are about four feet high, vegetated, and appear stable. The banks are generally gravel. Upstream from the bridge there are berms on both abutments that appear to be old piles of dredged materials. There is also a section of channel with rock vortex weirs that were constructed after the last major storm. Based on a visual assessment only the river is likely a C4 Rosgen classification.

Sediment deposition in and around the South Street bridge significantly reduces the capacity of the bridge. In future storms, debris clogging is very likely. This may cause additional upstream and road flooding. The upstream rock vortex weirs may be a restriction to fish passage upstream.

6. Site 7, the South Street Bridge, is severely restricted due to sediment deposition under the bridge and immediately upstream and downstream. Future floods will likely plug the bridge with sediment and/or woody debris, threatening the bridge or South Street. Although this sediment removal should correctly be evaluated in the context of a fluvial geomorphology study, its removal is recommended due to the possibility of near term flood damage to the bridge and roadway. It should be recognized that removal of sediment from the fluvial system at this location might have an upstream effect of increasing erosion. **(S)**

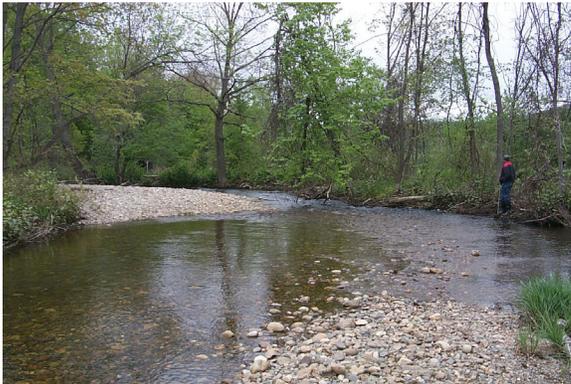
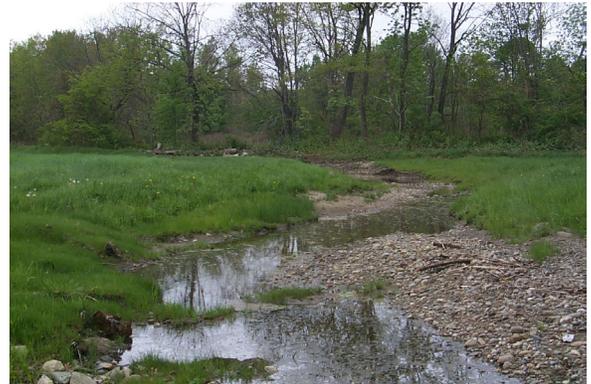
Site 8 looking downstream

Site 8 looking upstream
from field overflow

General – This site is about 250 feet long and is characterized by significant sediment deposition. The riverbanks are about four feet high and are generally vegetated. The bank material is generally gravel. There is a large point bar and debris accumulation on the left side of the channel. Obstructions are such that even small storms cause the river to overtop the right bank and flow through a cropped field. The dominant bed material is gravel and cobbles. Based on a visual assessment only, the river is likely a C4 Rosgen classification.

A large point bar has formed from an unknown sediment source. The deposition has reduced the channel capacity. During floods, water overtops the right bank carrying sediment onto a farm field and creating a new channel. Under present conditions, it is likely that the existing meander will be cut off and a new river channel will be created in the future. It should be noted that the farm field is floodplain and periodic overflows should be expected.

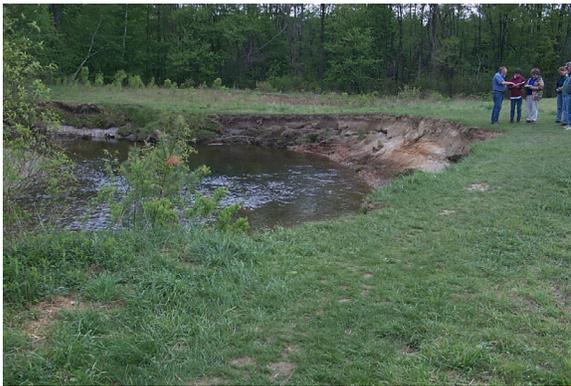
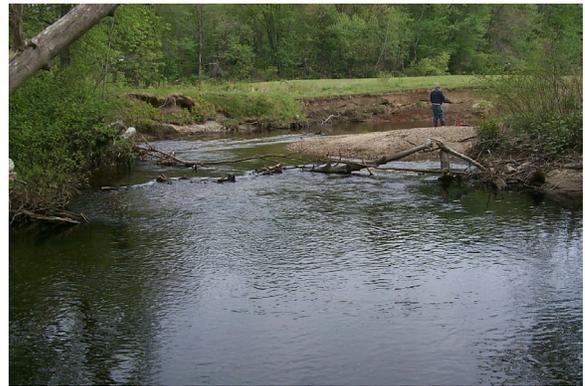
Site 9 looking downstream

General – This site is about 150 feet long and is characterized by a steep eroding right bank about six feet high. There is active bank erosion, an undercut toe of slope, some seeps, and some overhang. The bank material is generally sand with a clay layer near the bottom of the slope. Erosion is occurring on the outside of the meander bend and there is a significant point bar on the left bank. The dominant bed material is gravel and sand. There is some large woody debris immediately downstream from the site. Based on a visual assessment only, the river is likely a C4-C5 Rosgen classification.

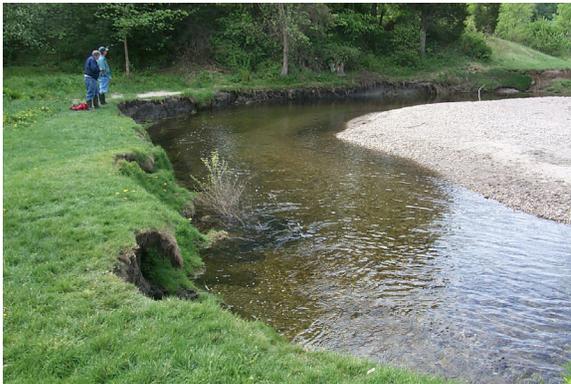
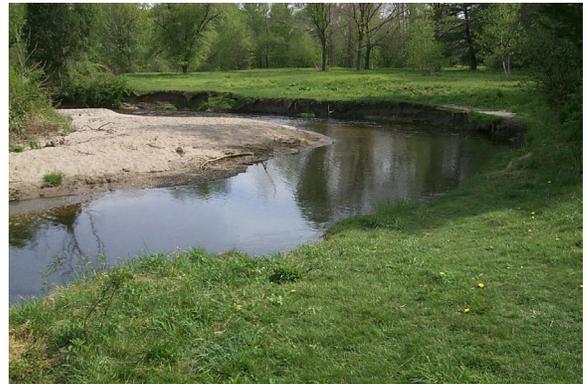
Site 10 looking downstream

General – This site is about 175 feet long and is characterized by a near vertical eroding left bank about four feet high. There is active bank erosion and some overhang. The bank material is generally sand. Erosion is occurring on the outside of the meander bend and there is a significant point bar on the left bank. The dominant bed material is gravel and sand. Based on a visual assessment only, the river is likely a C4-C5 Rosgen classification.

This site is likely located in the pool area of the former Bookmill Dam located downstream. This area appears to receive heavy foot traffic from fishers and recreation trail users. The left abutment is periodically mowed to the top of the bank. Just downstream from the site is a pool used for swimming, sand bags were observed in the water.

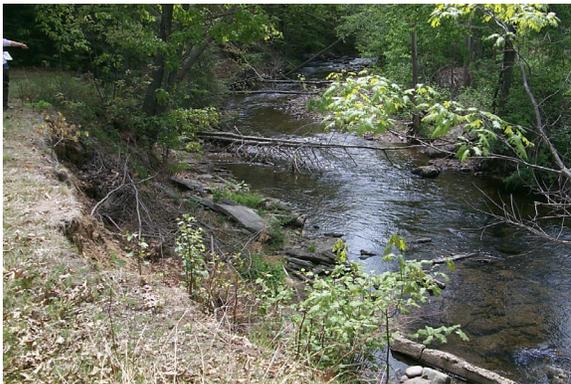
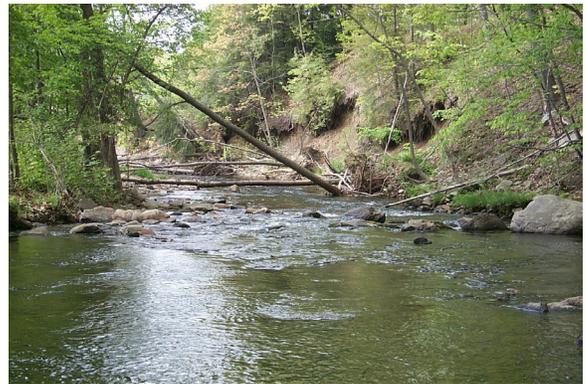
Site 11 looking Upstream

General – This site is about 350 feet long and characterized by a steep, eroding right bank about 12 feet high. There is active bank erosion with overhanging vegetation. The bank material is sand. The channel appears incised. The riverbed is stable. The dominant bed materials are cobbles and sand. Concrete slabs were noted on the bank and in the channel. Based on a visual assessment only, the river appears to be an F3 Rosgen classification.

Right Bank: This side is a residential lawn with some large mature trees scattered throughout, and grass to the stream edge. The bank is steep and eroding. There is Japanese Knotweed growing on the stream edge. Just upstream from grassed area, there is some forested riparian buffer consisting of oak-Sycamore-maple with an understory of sweet fern, Multiflora Rose, Japanese Barberry, honeysuckle and Burning Bush. On the lawn (Zone 2)

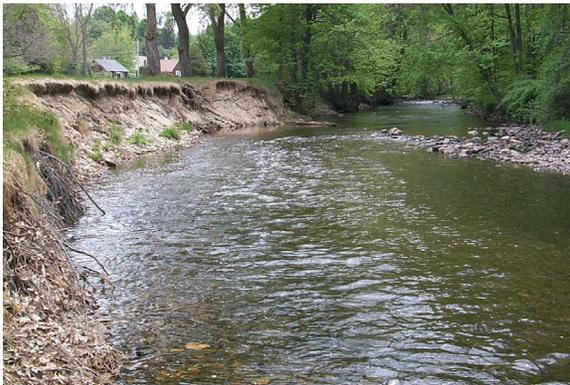
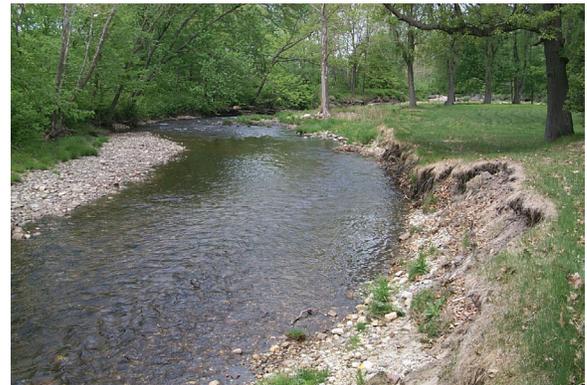
Site 12 looking Upstream

General – This site is about 375 feet long and characterized by a steep, eroding right bank about 8 feet high. There is active bank erosion with overhanging vegetation. The bank material is sand. The riverbed appears stable. The dominant bed materials are cobbles and sand. Based on a visual assessment only, the river appears to be a C4 Rosgen classification.

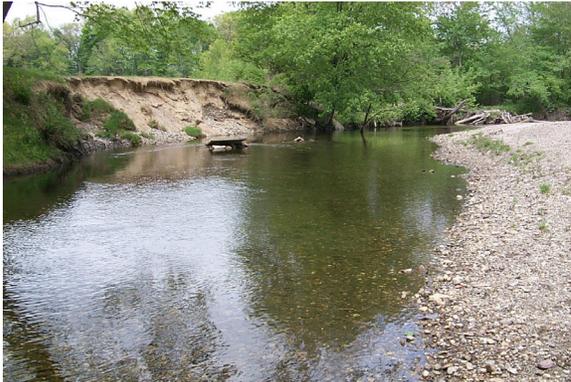
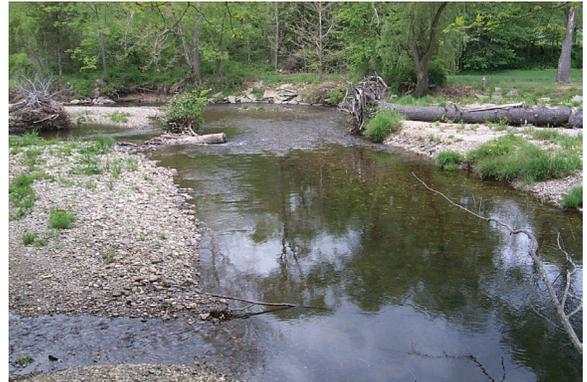
Site 13 looking Upstream

General – This site is about 400 feet long and characterized by a near vertical, eroding right bank about 5 feet high. There is active bank erosion with an undercut toe of slope. The bank material is gravel. The riverbed is appears to be aggrading. The dominant bed materials are gravel and sand. The upstream part of the site is braided channel due to large amounts of sediment deposition and debris. Based on a visual assessment only, the river appears to be a C4/D4 Rosgen classification. There is a cattle crossing at the downstream end of the site. Concrete debris was noted in the channel and on the downstream right bank.

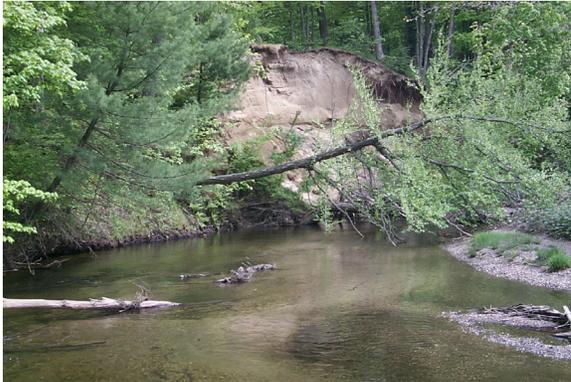
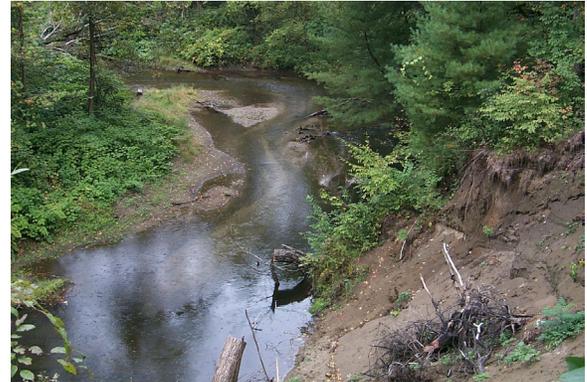
Site 14 looking Downstream

General – This site is about 180 feet long and characterized by a steep, eroding left bank about 40 feet high that has failed. Meadow Road is located about 20 feet from the top of the slide. There is active bank erosion with an overhanging bank and seeps. The bank material is sand. The riverbed appears to be aggrading. The dominant bed materials are gravel and sand. Based on a visual assessment only, the river appears to be a C5 Rosgen classification.

4. Site 14, adjacent to Meadow Road, warrants immediate corrective action because of the threat to Meadow Road. As of October 2001, this site is being addressed and repair funded under the NRCS Emergency Watershed Protection Program. This action will remove the threat to
