**SUPPLEMENTAL
WATERSHED PLAN No. 6 &
ENVIRONMENTAL ASSESSMENT**
For Rehabilitation of the
Hop Brook Floodwater Retarding Dam
SuAsCo Watershed
Worcester County, Massachusetts

DRAFT
Supplemental Watershed Plan No. 6 & Environmental Assessment
for Rehabilitation of Hop Brook Floodwater Retarding Dam
SuAsCo Watershed
Worcester County, Massachusetts

**Supplemental Watershed Plan No. 6 & Environmental Assessment
for Rehabilitation of Hop Brook Floodwater Retarding Dam
SuAsCo Watershed
Worcester County, Massachusetts**

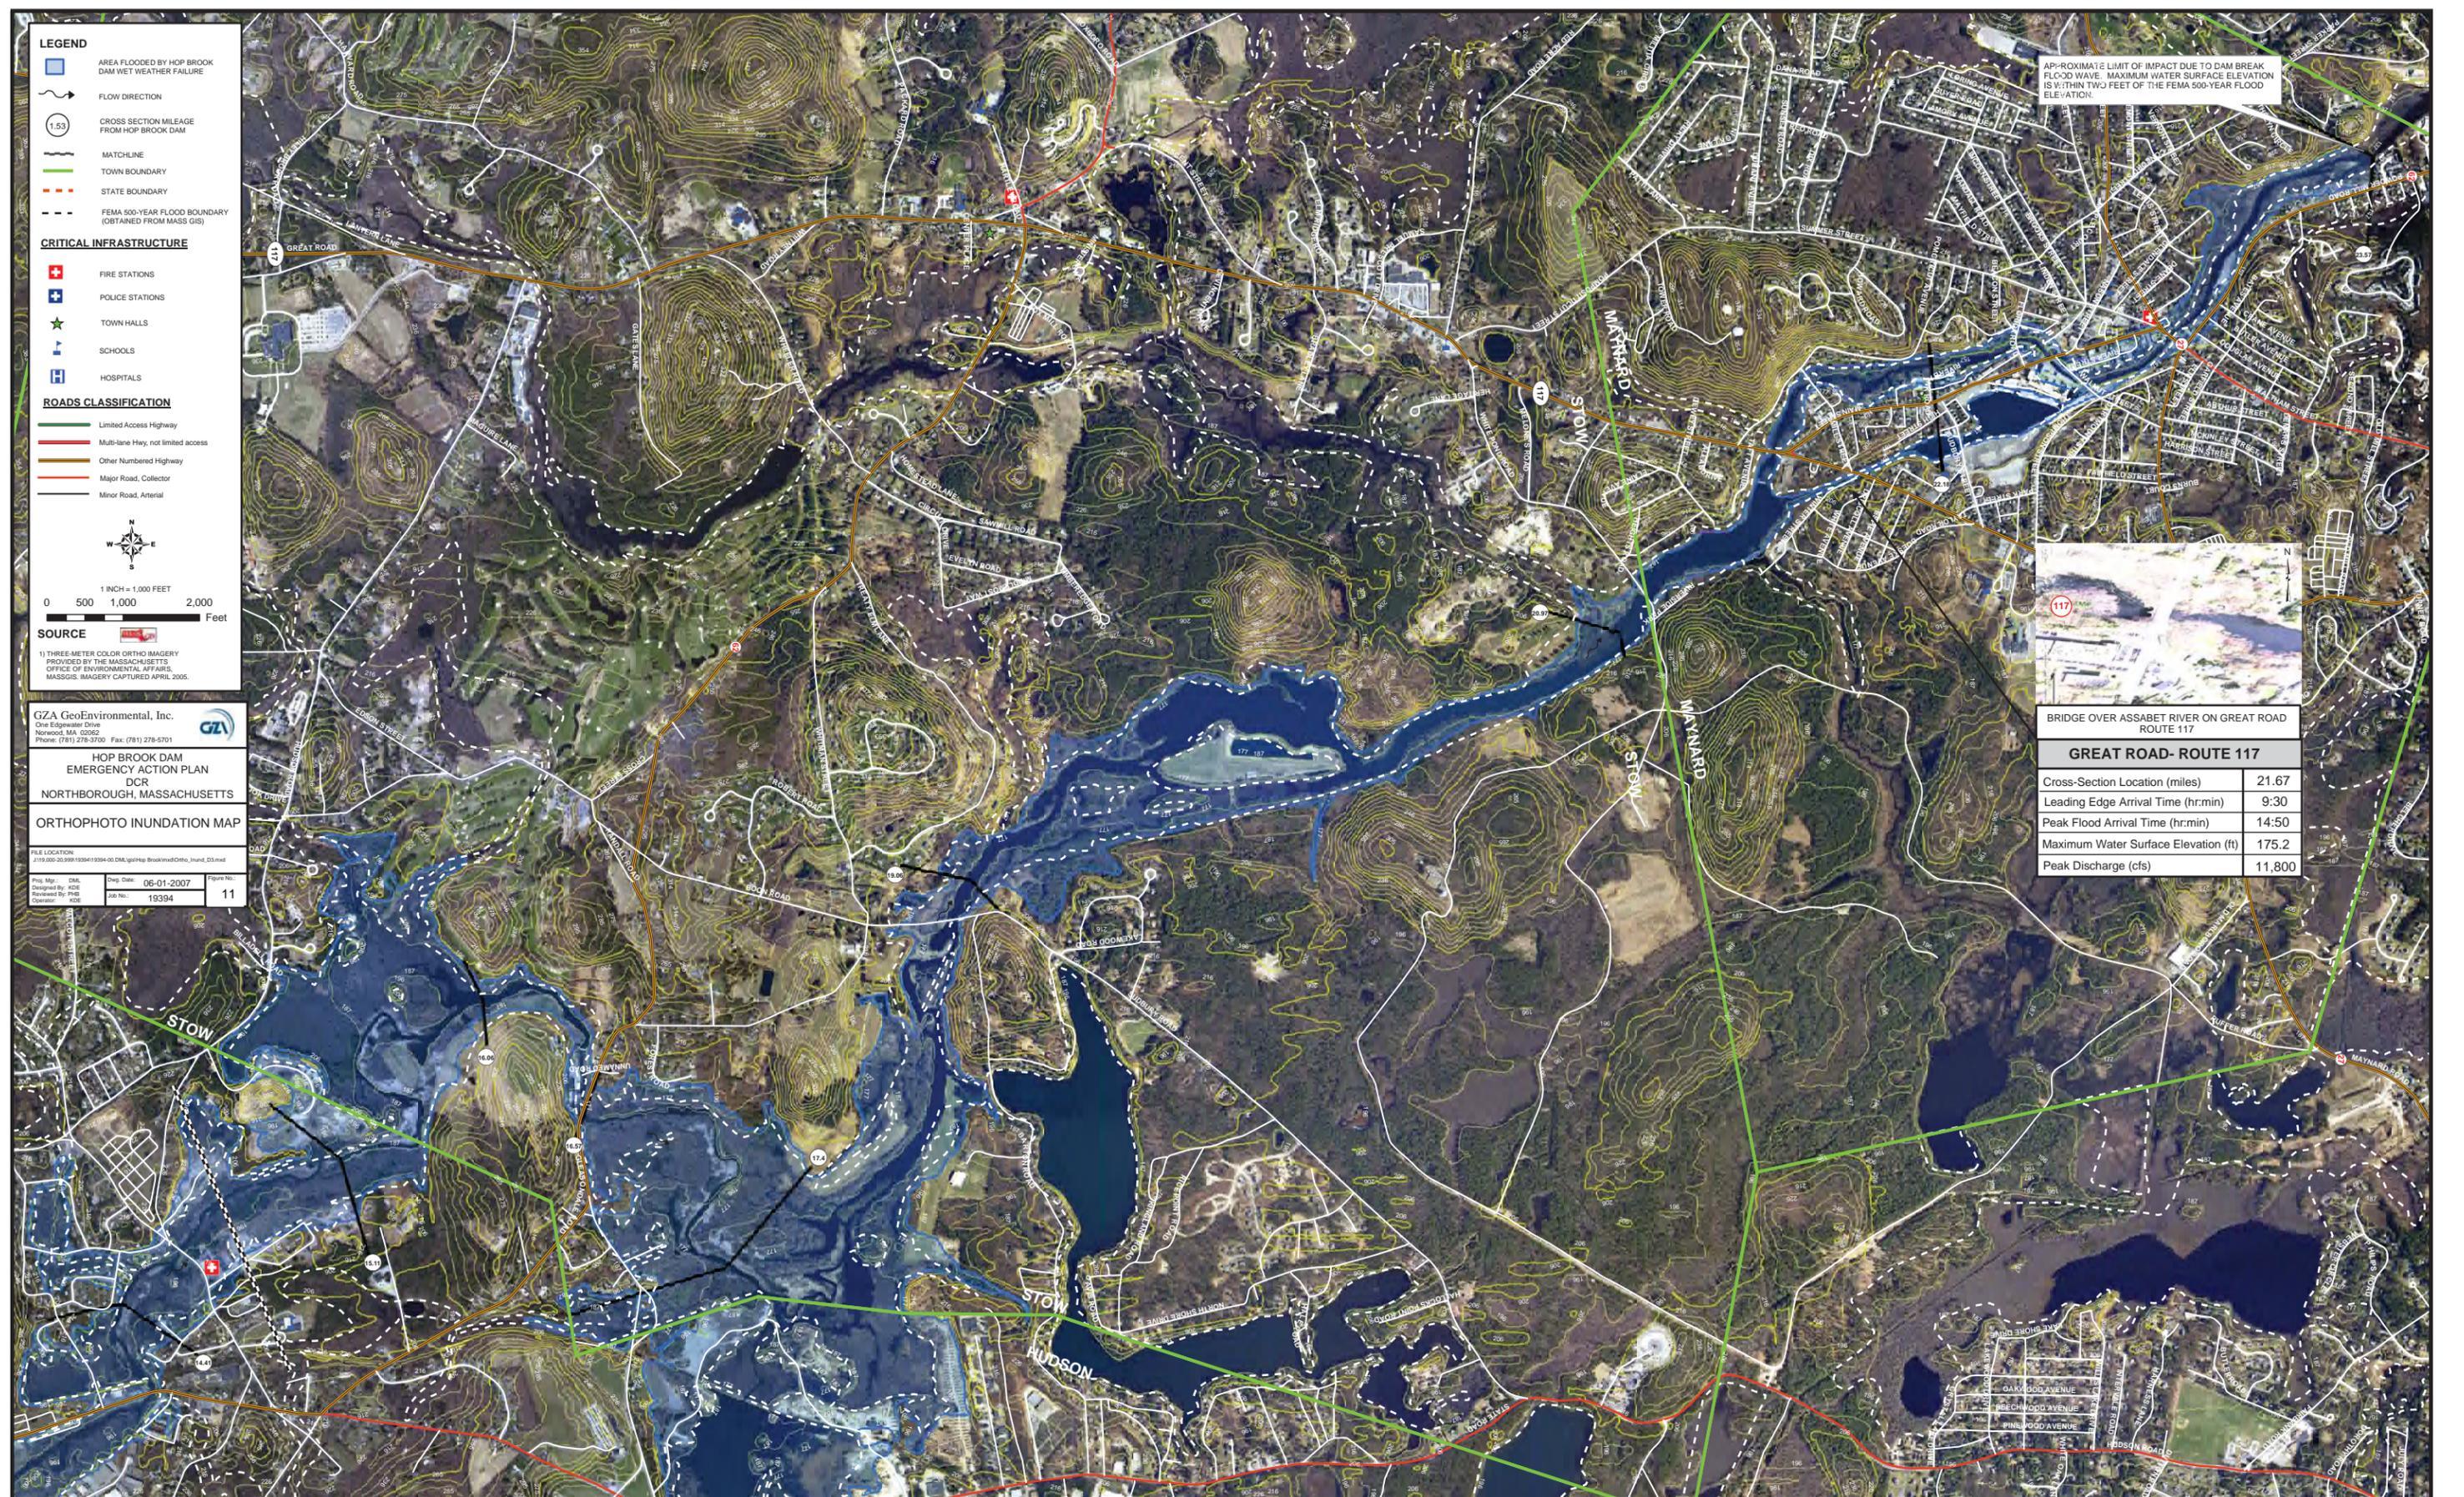
GREAT ROAD- ROUTE 117

Cross-Section Location (miles)	21.67
Leading Edge Arrival Time (hr:min)	9:30
Peak Flood Arrival Time (hr:min)	14:50
Maximum Water Surface Elevation (ft)	175.2
Peak Discharge (cfs)	11,800

The modeling determined that the maximum discharge through the Hop Brook Dam breach opening is approximately 19,500 cfs and occurs 0.5 hours from the beginning of the simulation. The peak dam flow is expected to be an order of magnitude greater than the 100-year flood for the Assabet River within the Town of Northborough. Peak flood depth over initial conditions ranges from about 4 feet immediately downstream of the dam to about 1 foot downstream of Tyler Dam and approximately 2.5 feet downstream of Washington Street Dam. Inundation maps presenting the results of the DAMBRK modeling are located in Appendix C, Figures 9-11.

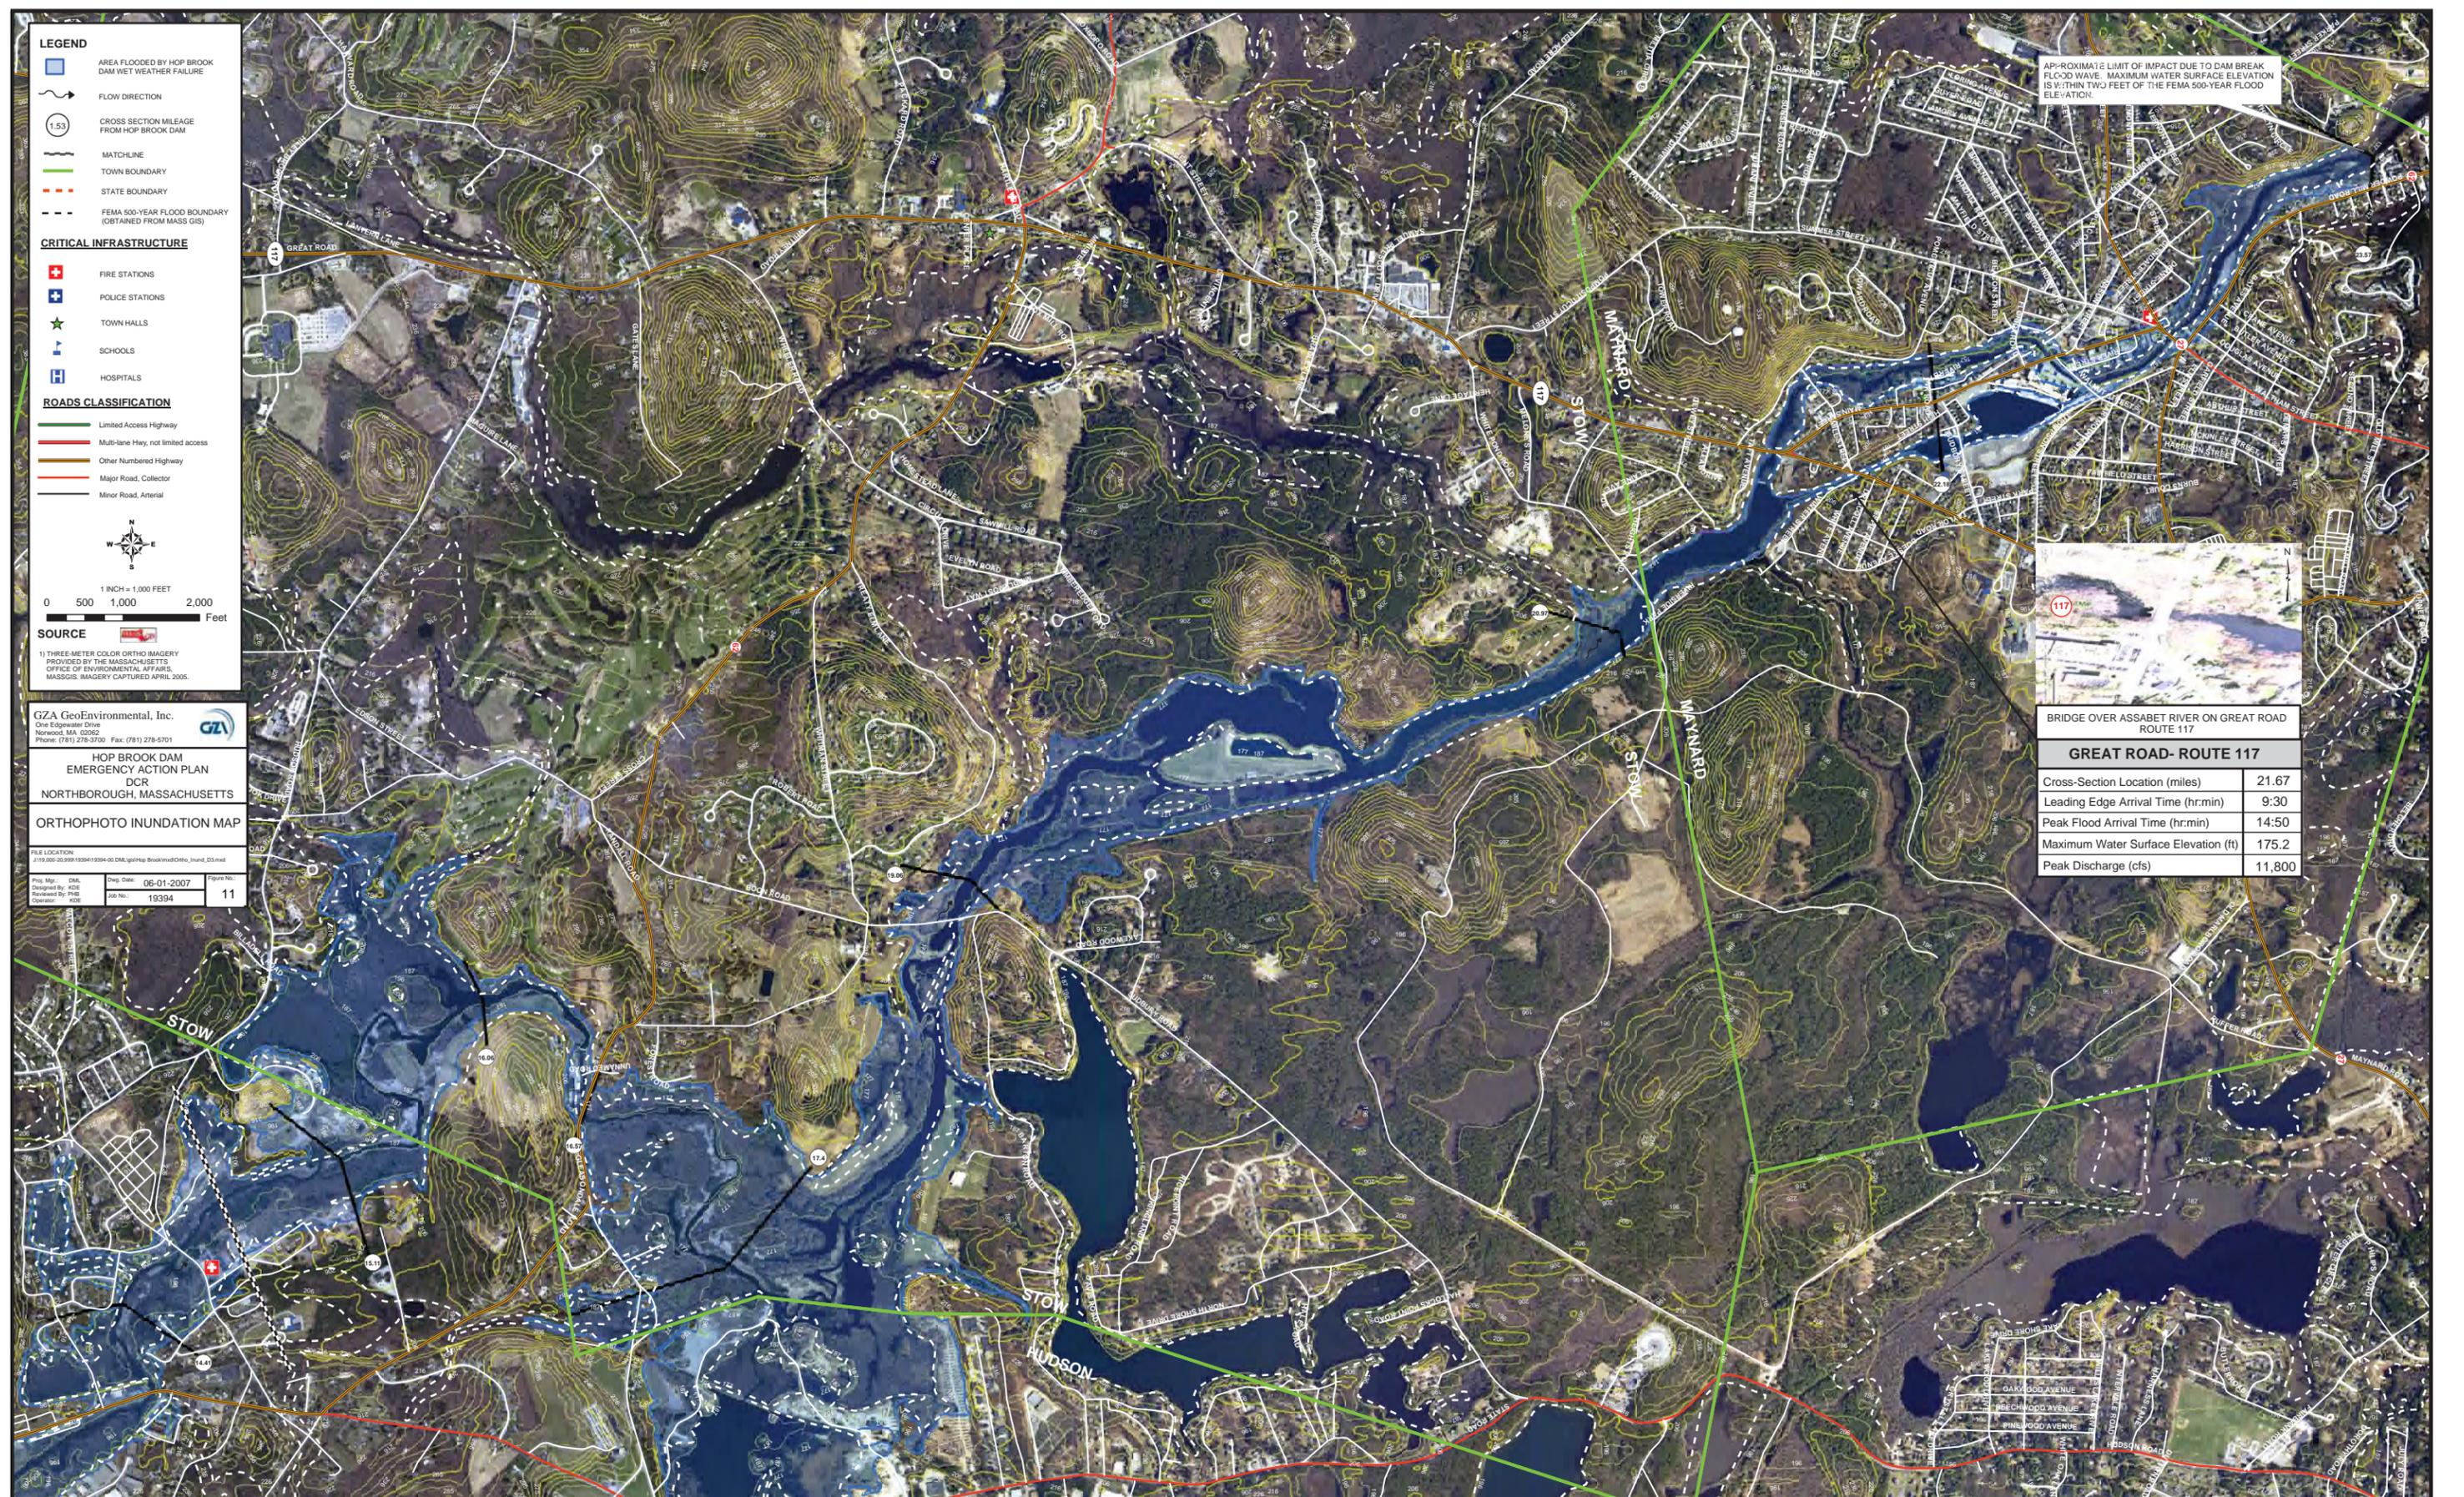
BRIDGE OVER ASSABET RIVER ON GREAT ROAD ROUTE 117

GREAT ROAD- ROUTE 117	
Cross-Section Location (miles)	21.67
Leading Edge Arrival Time (hr:min)	9:30
Peak Flood Arrival Time (hr:min)	14:50
Maximum Water Surface Elevation (ft)	175.2
Peak Discharge (cfs)	11,800
